Advice Note:

Corrosion Of Tower Legs and
HD Bolts at Foundation Level.

FLI Document Reference: FLI 2025/004

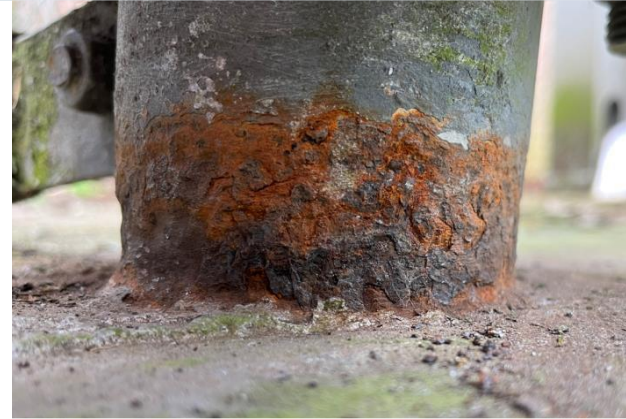
Corroded tubular legs
(the internal space was also corroded).

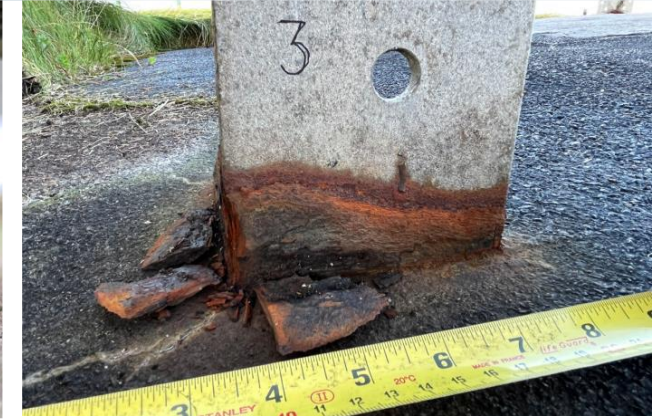
Corroded Angle Stubs.

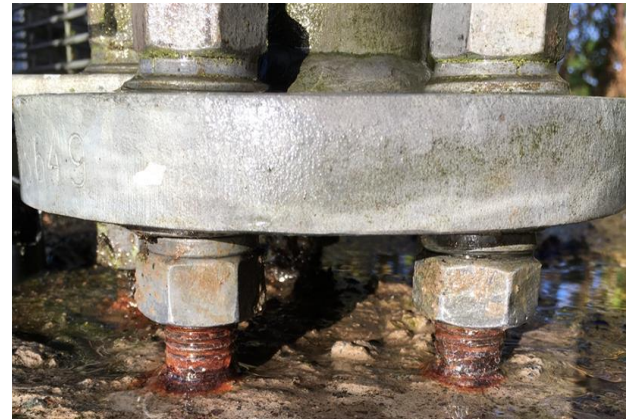
Corroded Hold Down Bolts.

Grouting Hold down bolts to encase them in a protective environment and negate any detritus buildup.

(consideration should also be given to preloading the HD Bolts to mitigate against fatigue)

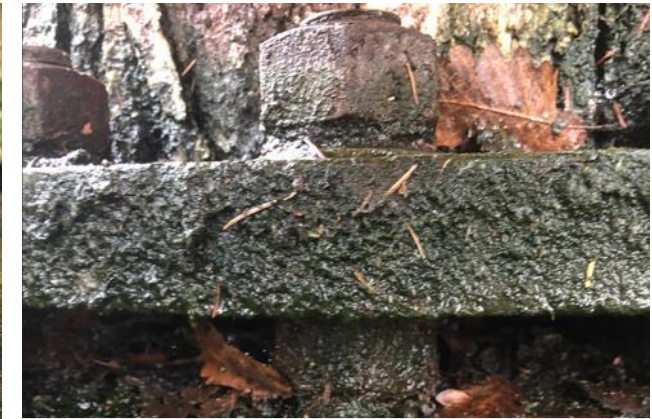
Build-up of Detritus with Corroded Nuts.

It is essential that these critical locations of towers are inspected and cleaned regularly and thoroughly so that any corrosion is identified and remediated early on.
